## CCTV DRAIN SURVEY

1 Jonny Street, Westerham, Kent, TN16 1EJ.

Project Name	Project Number	Project Date
SAMPLE DRAIN SURVEY		18/10/2022

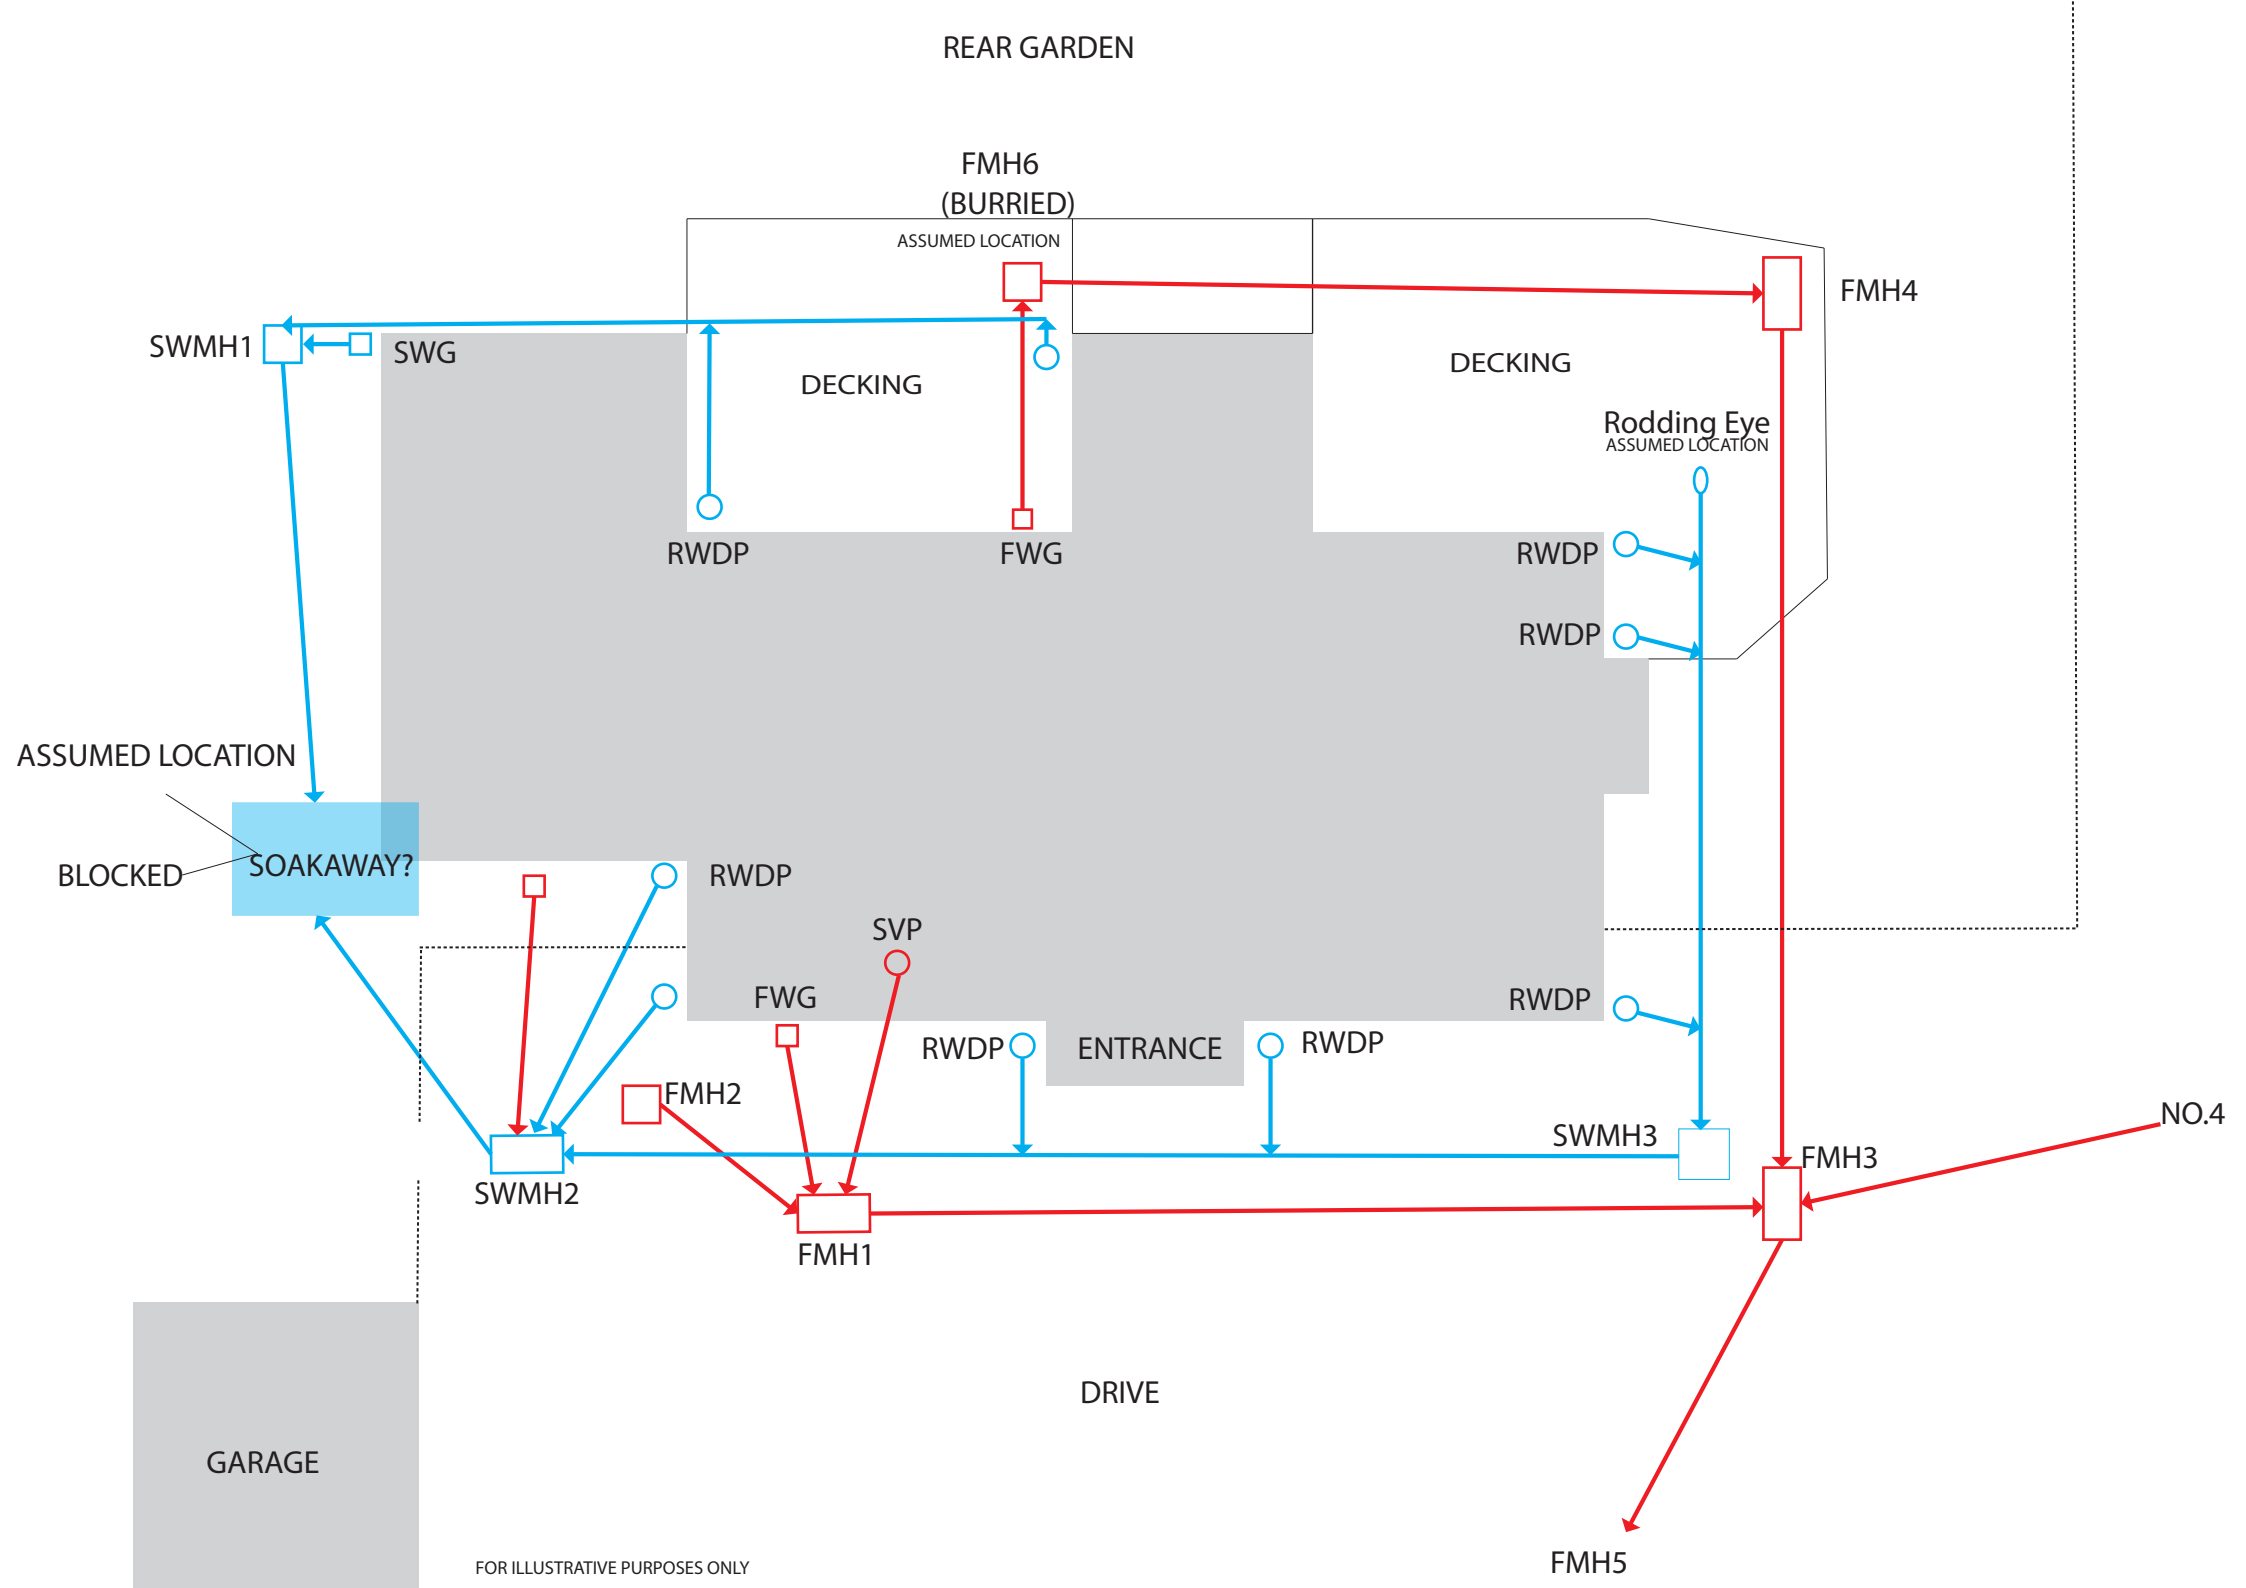
The foul drainage system comprises of five inspection chambers within the property boundary before then discharging into a sixth, located outside No.2 Jonny Street.

The overall condition of the foul drainage system is good, there were no structural defects noted, however, there are some roots growing within FMH3. The system was found to be clear and free flowing during our visit.

FMH6 is believed to be under the decking, this could not be accessed. This may provide access to other branch lines that have not yet been surveyed.

The Surface water drainage system comprises of three inspection chambers within the property boundary before then discharging into what we believe to be a soakaway (see attached drawing).

Using CCTV and Sonde Locator, we traced SWMH1 and SWMH2 downstream to the corner of the building (see attached drawing), unfortunately our camera could not confirm it as a soakaway as it's blocked and full of water.

We noted a connection coming from the utility room enters the surface water drainage system, this could easily block a soakaway and could be the cause. If we have identified this correctly, the soakaway has failed and is located too close to the building if not under it.

SWMH3 has been put in backwards, this isn't a major problem but should be noted.

Further investigation is required to establish exactly where the soakaway is.

- The surface water drainage system should be pumped out to allow further CCTV and sonde locating to establish where and why the drains are blocked.
- The local water authority should be contacted to confirm if FMH3 and downstream have been adopted.

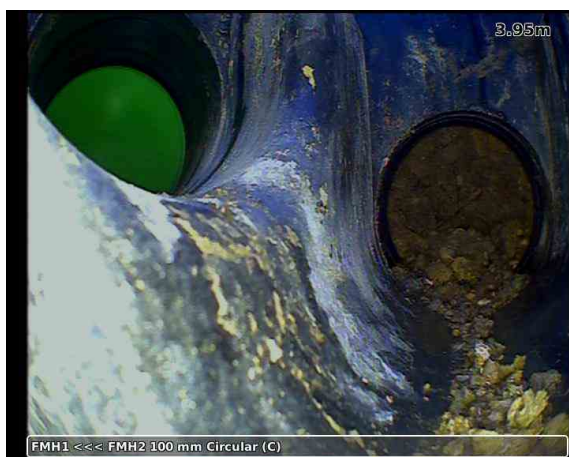
20221018-065023-snap0002.jpg, 00:00:37, 3.95 m  
Finish node, manhole, reference: FMH2, MAIN RUN  
UNCAPPED

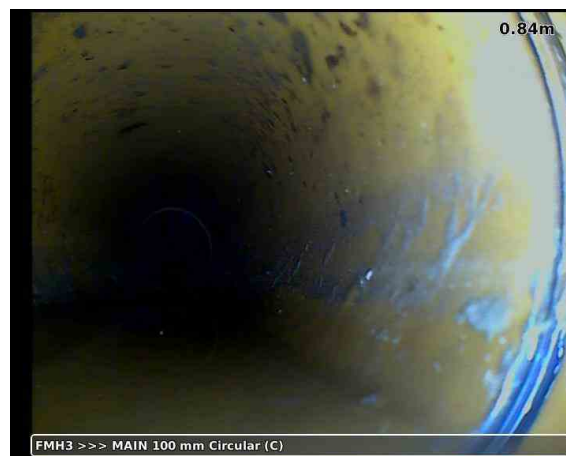
20221018-070631-snap0001.jpg, 00:00:08, 0.84 m  
Water level, 10% of the vertical dimension

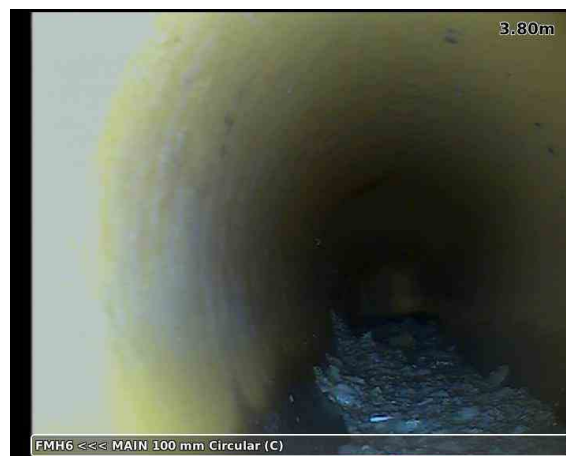
20221018-072019-snap0001.jpg, 00:00:34, 3.80 m  
Settled deposits, fine, 10% cross-sectional area loss

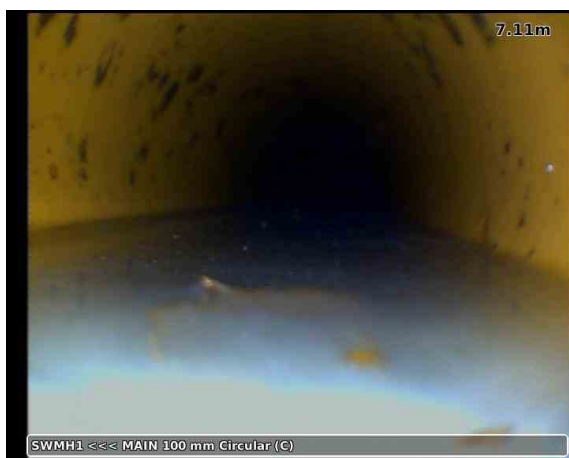
20221018-073624-snap0004.jpg, 00:00:48, 7.11 m  
Water level, 50% of the vertical dimension

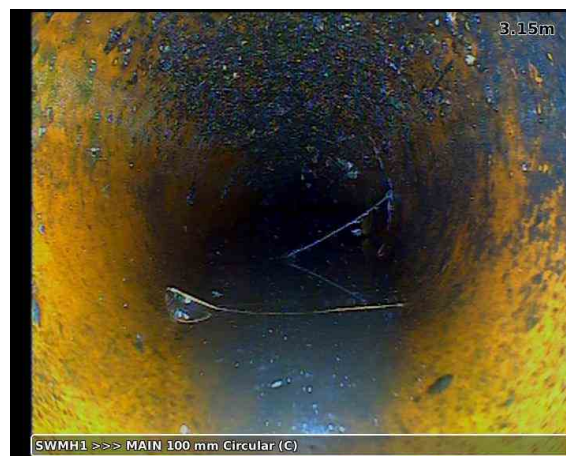
20221018-074145-snap0001.jpg, 00:00:14, 3.15 m  
Water level, 100% of the vertical dimension
